CERTIFICATE OF TEST

DATE OF ISSUE: **30 June 2021** CERTIFICATE NUMBER: **U4050-1**

INGRESS PROTECTION TEST- IPX2:
PHOTOGRAPHIC RECORDS

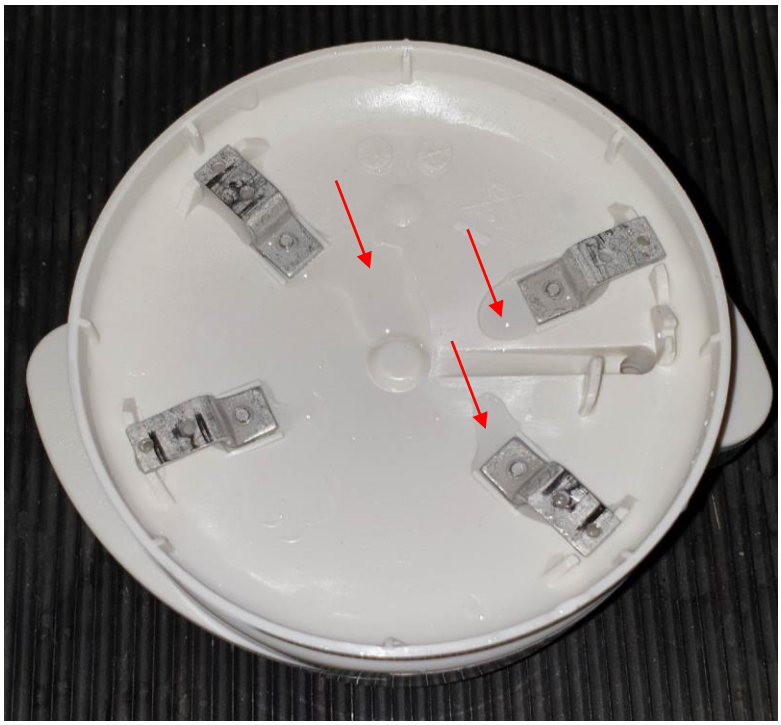
Following customer instruction, ETS set the test item to function throughout the water ingress test. The test item status indication was observed to be normal throughout the test.
Following the water ingress test and before the post-test inspection, the test item was subjected to a smoke detector test. This activated an audible response and the expected alarm indication on the connected control panel.
Opinions regarding test item functionality are outside the ETS schedule of UKAS accreditation.
Post IPX5 test inspection:
The post-test inspection was performed by ETS.
During the post test inspection, some water ingress was found. See attached photographs.

Post-test inspection: Water ingress visible (Sounder)

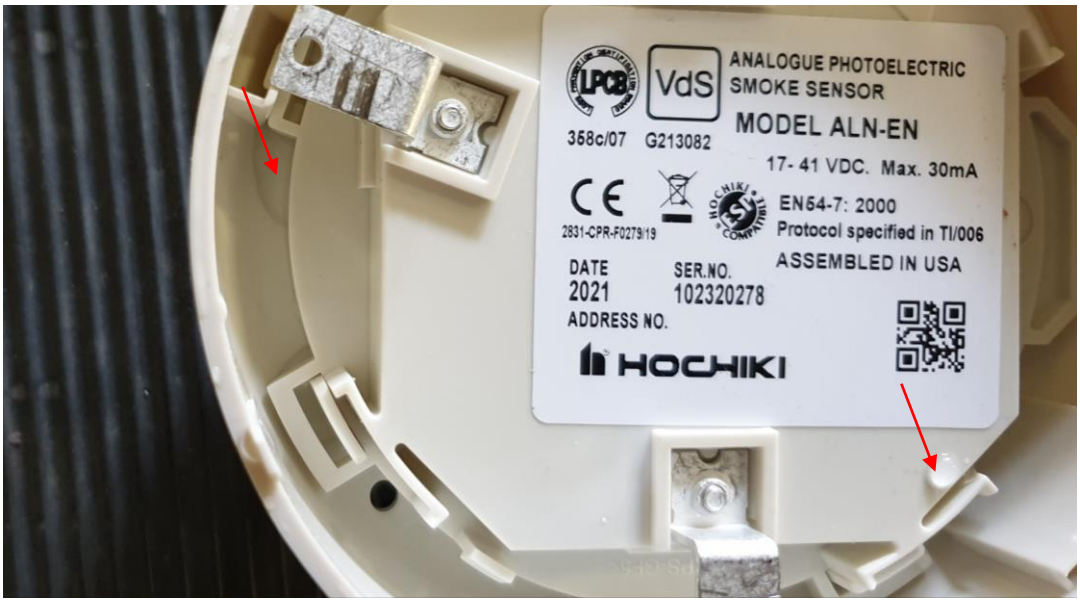
Post-test inspection: Water ingress visible (Sensor)

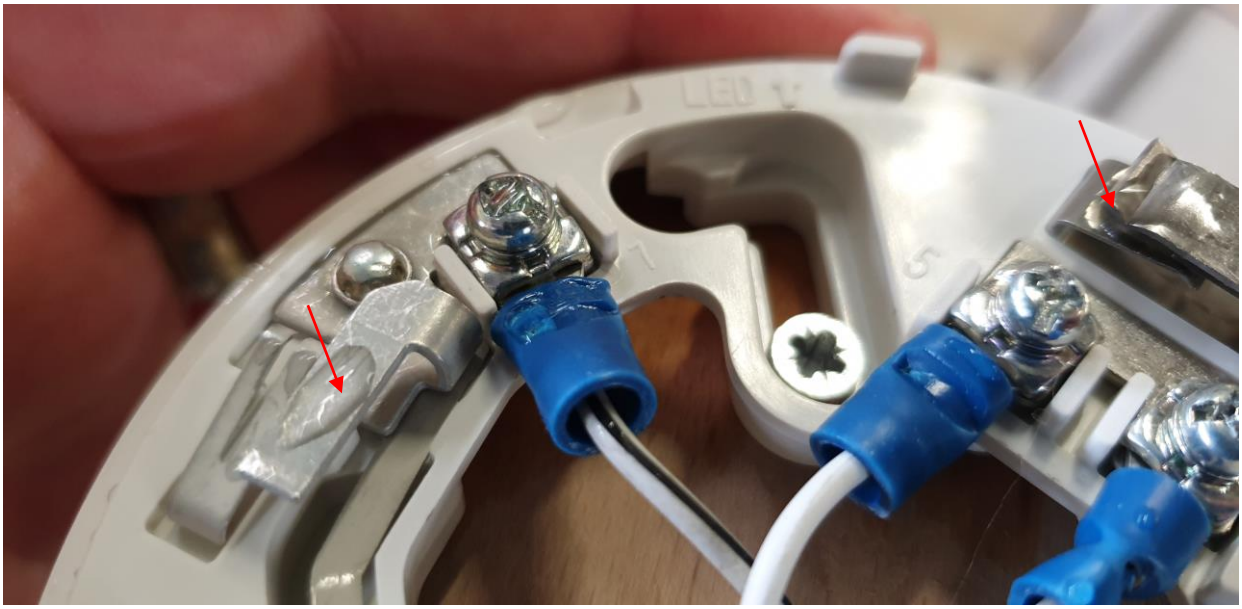
Post-test inspection: Water ingress visible (Base)

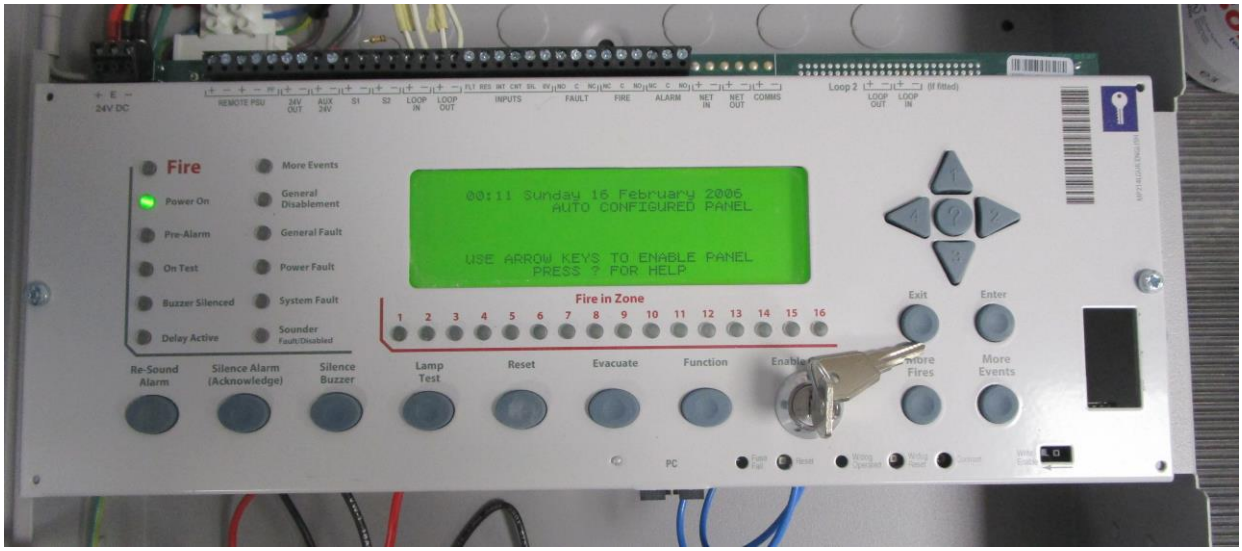
Control panel, display in non-alarm state

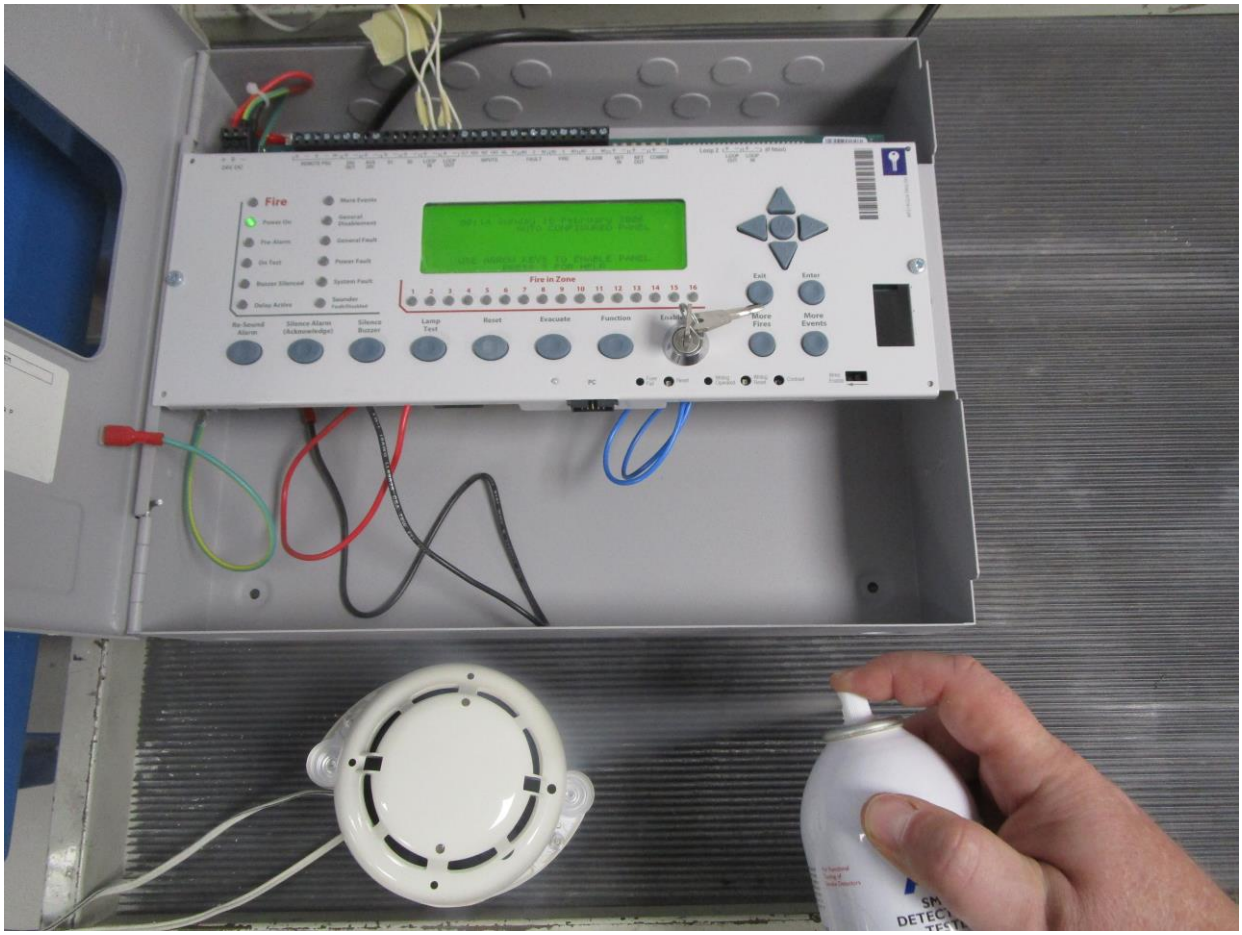
Test item being exposed to AS Smoke Detector Tester

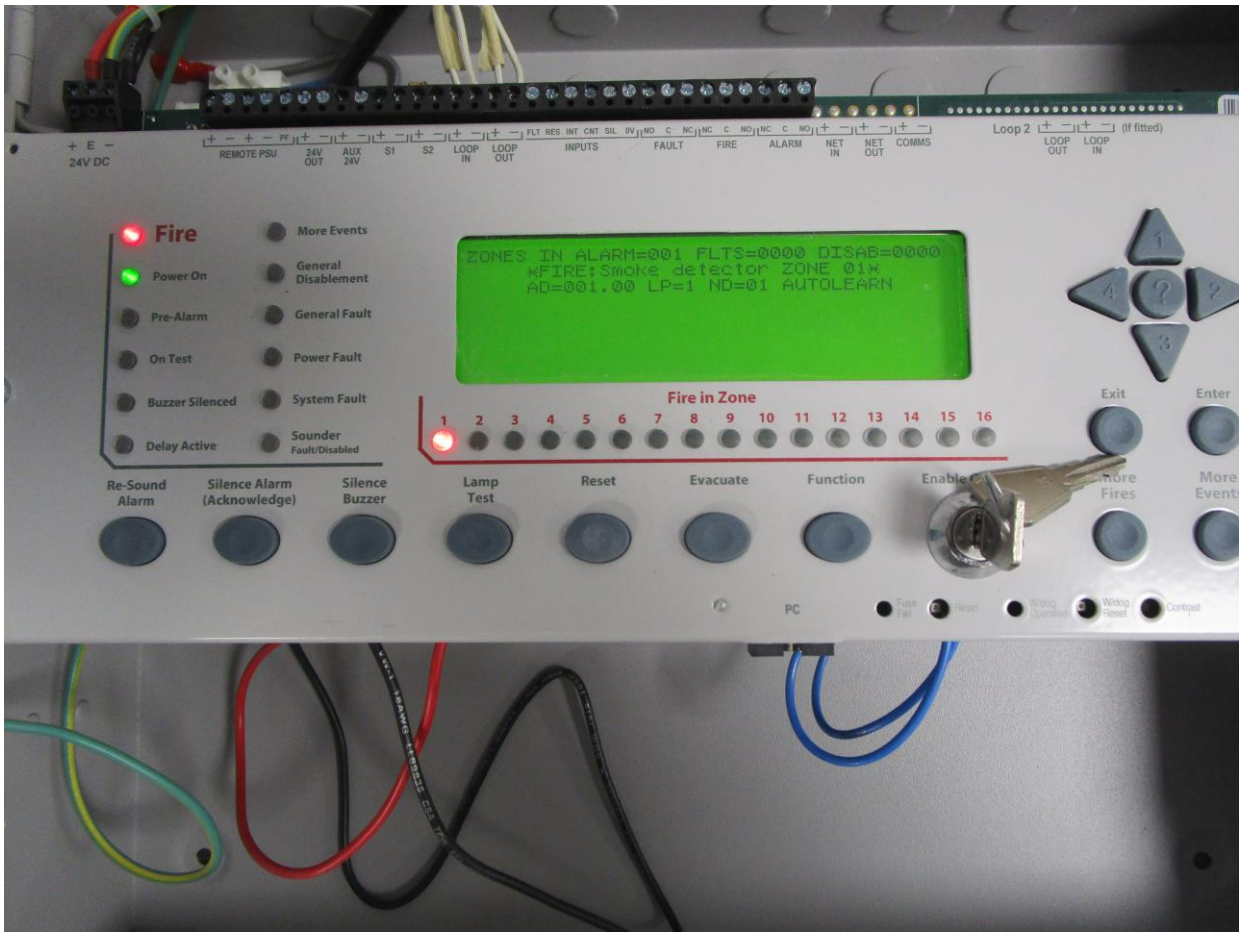
Control panel display in fire alarm state (triggered by AS Smoke Detector Tester)
