Certificate of Testing

Serial Number: 11793CC01A

Specimen: 1 off — MCP Call Point
TRaC. Stores No.: 23702
Receipt Date: 4th August 2009

Specification: Ingress Protection Testing
Tested in accordance with BS EN 60529:1992.

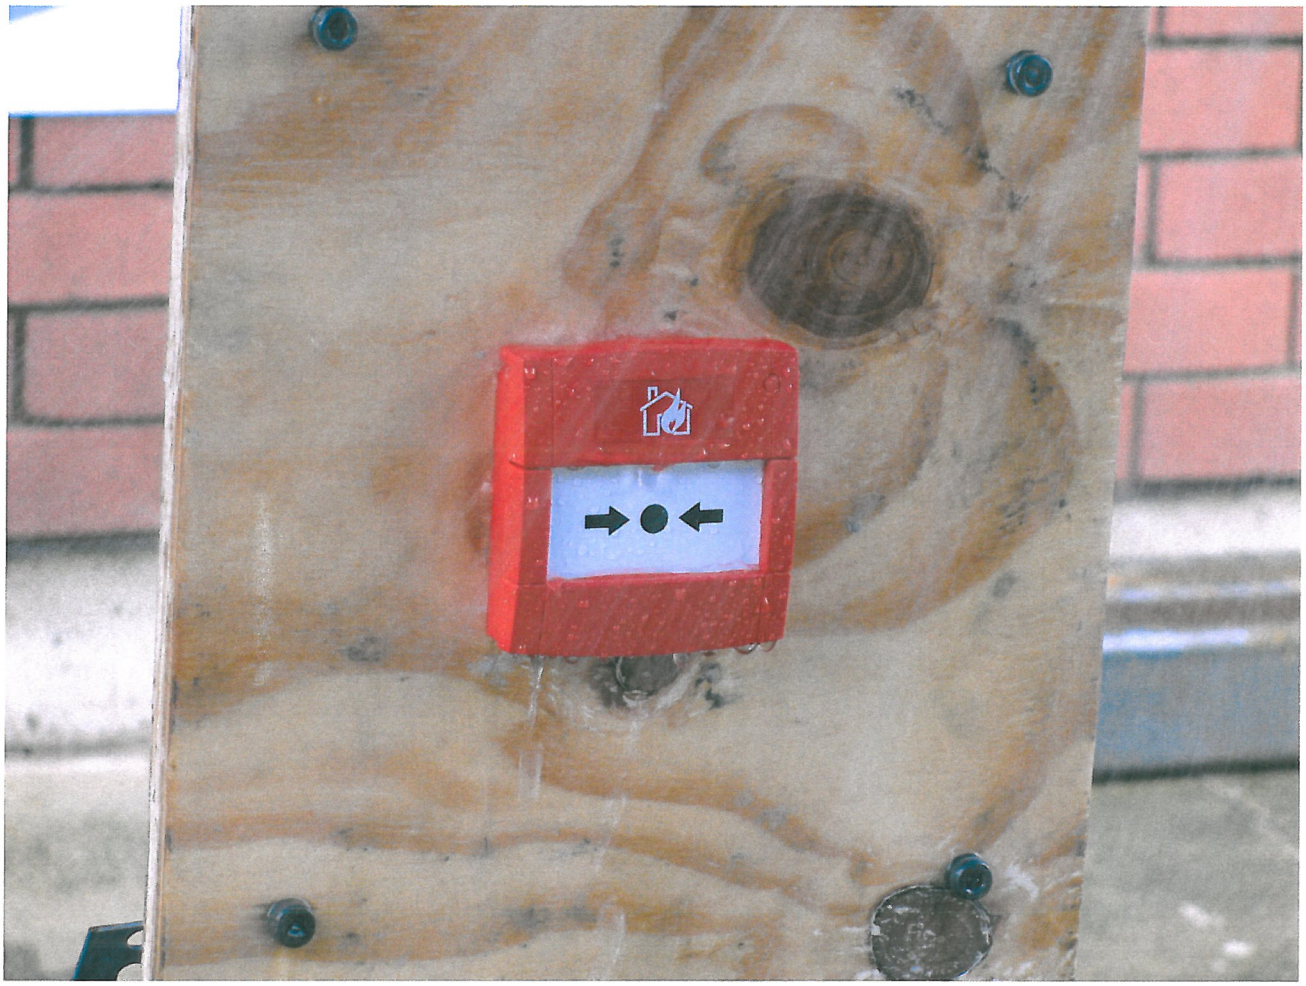
Figure 1

After testing the specimen was dried externally before being inspected internally for water ingress. Some water was found but not in areas or quantities that would affect the safety or function of the specimen.

Specimen undergoing water test
